Inspection Services – Carpet, Flooring, Upholstery

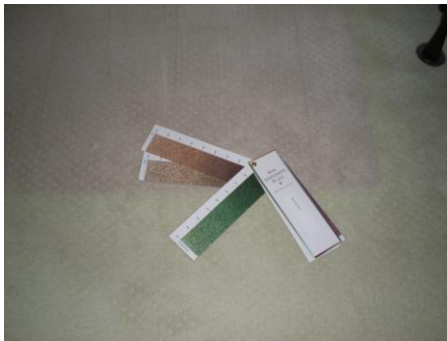
On the left is a carpet manufacturing issue – fume fading. The carpet started out tan and gradually turned light green. A hope chest was moved revealing the original color. The item in the middle of the picture is a ‘Gray Scale’ kit.

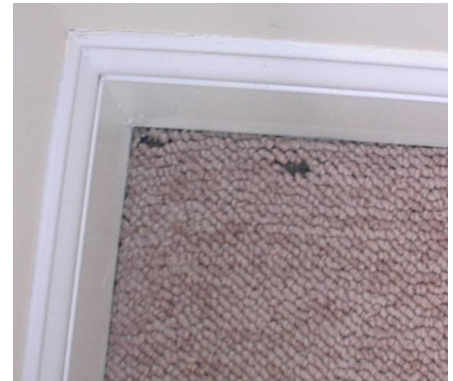
The picture on the right shows an installation issue. The installer used a staple gun to attach the carpet to the tack strip. It pulled off during the

installation, pulling the loops out from below. The black you see is the backings.

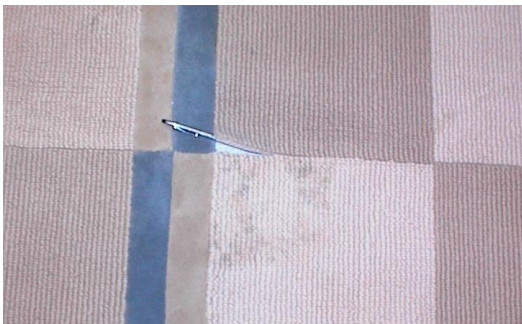
On the left we have a ‘Specification’ issue. They used the incorrect face yarns. This hand cut wool carpet was installed on a boat. Wool is prone to mold damage when exposed to high humidity situations, such as an enclosed boat. Also the glue used on the backings was inappropriate as it failed due to the moisture.

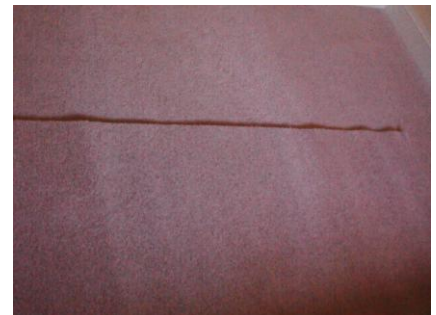
On the right, we have a non-issue. A real estate agent claimed the carpet cleaner caused the streaks in the carpet. The problem is reflections from dividers inside the window. When the window treatments were removed, the streaks appeared. The black line in the middle of the photo is from a spare piece of carpet to prove the case.

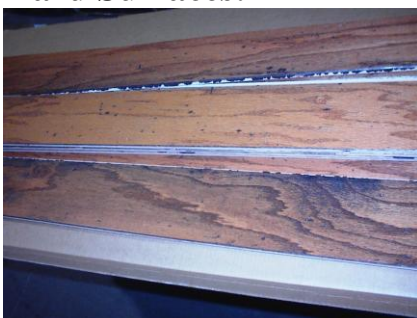
On the left is a manufacturing issue. The boards were treated with a darkening agent to simulate a distressed look. Uneven application resulted in heavy staining and blotches. The owner rightly refused the shipment of flooring.

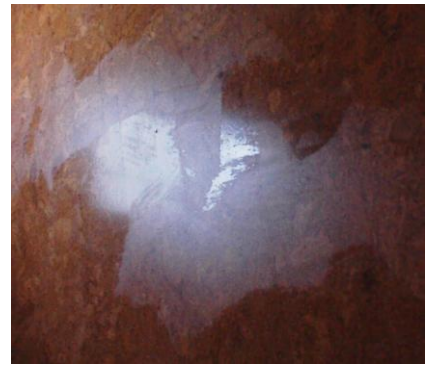
On the right is an issue where the installer did not put on even coats of sealer on this cork floor. The installers claim that the flooring was defective was not substantiated.

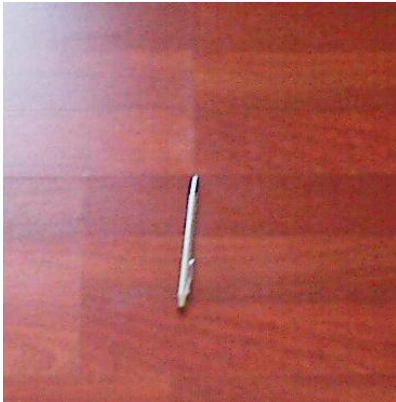
On the left is an issue where the composite flooring had ridges at the ends and sides of the planks. The tongue and groove pieces snap into place. What happened is the groove part was forced upward during the installation. As there were no spare pieces it could not be determined if a heavy handed installer caused the problem or if there was excessive moisture (climate control issue) that caused swelling or possibly the tongue and grooves were incorrectly sized.
