Inspection Services – Carpet, Flooring, Upholstery – p.1

Carpet:

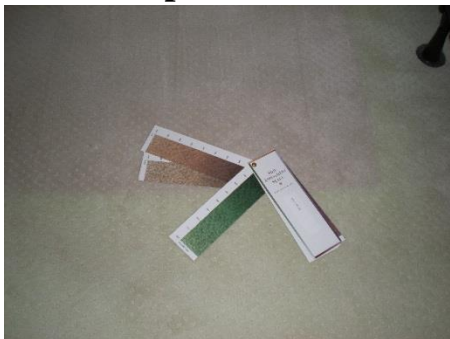
On the left is a carpet manufacturing issue – fume fading. The carpet started out tan and gradually turned light green. A hope chest was moved revealing the original color. The item in the middle of the picture is a ‘Gray Scale’ kit which allows me to tell the manufacturer exactly the magnitude of color change.

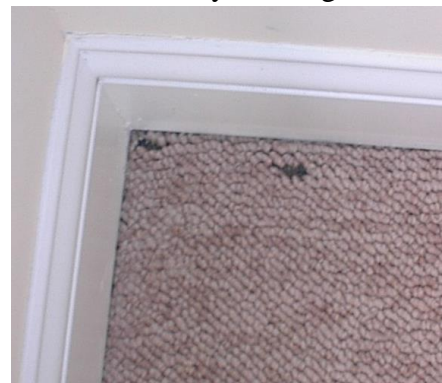
The picture on the right shows an installation issue. The installer used a staple gun to attach the carpet to the tack strip. It pulled off during the installation, pulling the loops out from below. The black you see is the primary backing.

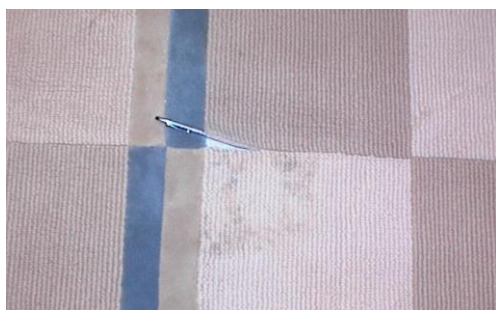
On the left we have a ‘Specification’ issue. They used the incorrect face yarns. This hand cut wool carpet was installed on a boat. Wool is prone to mold damage when exposed to high humidity situations, such as an enclosed boat. Also the glue used on the backings was inappropriate as it failed due to the high moisture levels.

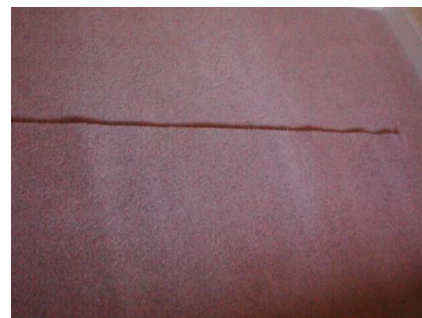
On the right, we have a non-issue. A real estate agent claimed the carpet cleaner caused the streaks in the carpet. The problem is reflections from the silver dividers inside the thermo pane windows. When the window treatments were removed, the streaks appeared. The black line in the middle of the photo is from a spare piece of carpet I put on top for proof.

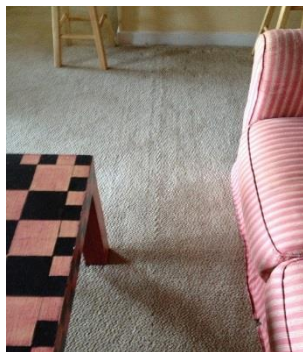
On the left is an installation issue. The installer placed a seam that runs perpendicular to the window. Any light coming through will magnify any changes of the height of the carpet. What you are seeing is both the height of seam tape as well as the seam itself.

The installation standards (CRI 105) state that any seam should run parallel to a window to minimize seam visibility. Seams should also be out of traffic lanes wherever possible.

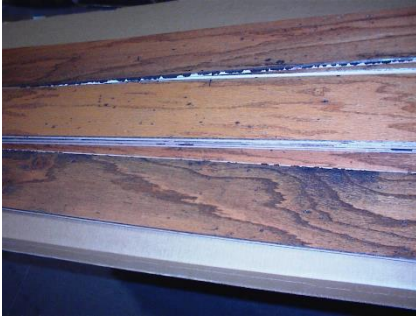
On the left is a manufacturing issue. The boards were treated with a darkening agent to simulate a distressed look. Uneven application resulted in heavy staining and blotches. The owner rightly refused the shipment of flooring.

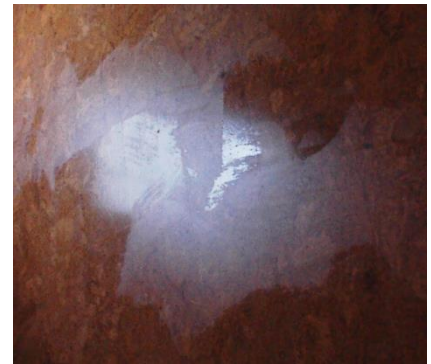
On the right is an issue where the installer did not put on even coats of sealer on this cork floor. The installers claimed that the flooring was defective. My inspection proved that was not the case.

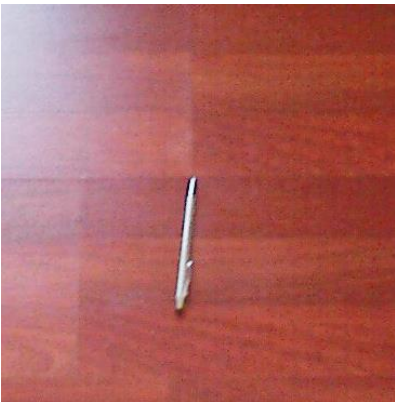
On the left is an issue where the composite flooring had ridges at the ends and sides of the planks. The tongue and groove pieces snap into place. What happened is the groove part was forced upward during the installation. As there were no spare pieces it could not be determined if a heavy handed installer caused the problem or if there was excessive moisture (climate control issue) in the product when it was installed that caused swelling.
